## Guide to Fixing Pump Failure Issue

There are mainly 2 reasons which causes the pump not able to work properly.

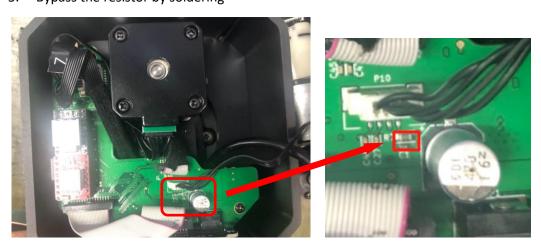
5. Bypass the resistor by soldering

A, The resistor on the PCBA is burn out;

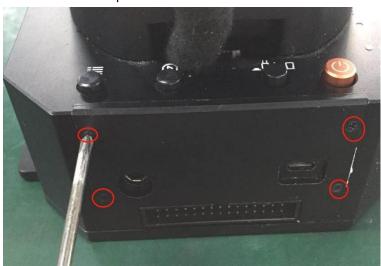
1.1 Remove the 4 pcs M2\*5 screws on the base side cover.

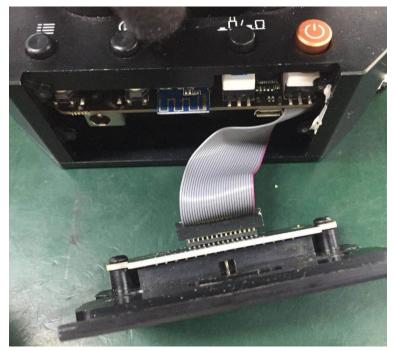
1.2 Remove the base side cover.

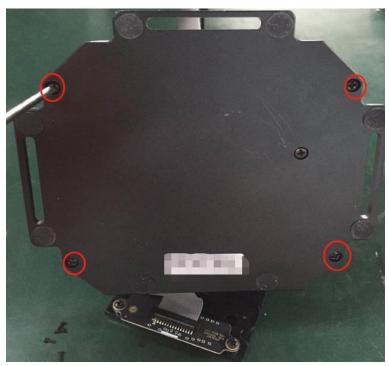
1.3 Remove 4 M3\*5 screws on the bottom of the uArm base bottom cover.

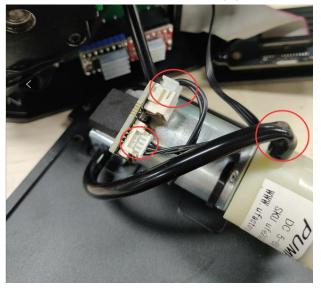
1.4 Remove all the cables and the pipeline from the pump.

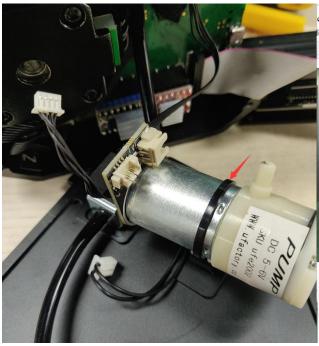
1.5 Cut the cable tie which is used to fix the pump.

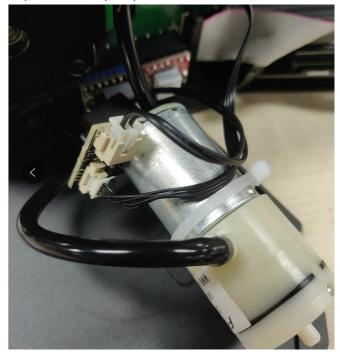
2.1 Replace a new pump, fix it with a new cable tie.

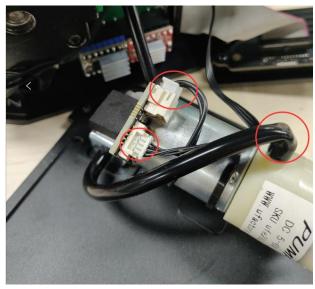
#### 2.2 Connect all the cables and tube

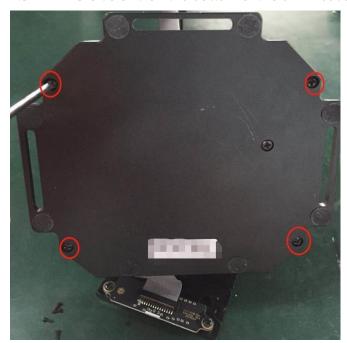
2.3 Fix 4 M3\*5 screws on the bottom of the uArm base bottom cover.

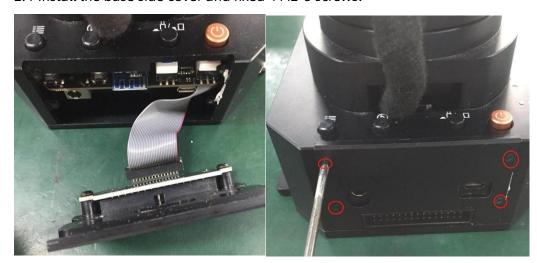
2.4 Install the base side cover and fixed 4 M2\*5 screws.
